ENGINEERING AND TECHNICAL SERVICES REPORT

EVALUATION OF WOOD POLE FIRE RETARDANT TREATMENT			DATE May 25, 2017	REPORT NO. TEST-17-050-Revised
			AUTHOR J.G. Hildreth – TEST-MODA <i>JGH</i>	
			Assisted By R.S. Dizon – TEST-MODA	
REQ ORG. TELM	PAGES 5	ABMW.O. 17-035	REVIEWED BY S. Khem – TEST-MODA <i>S. Khem</i>

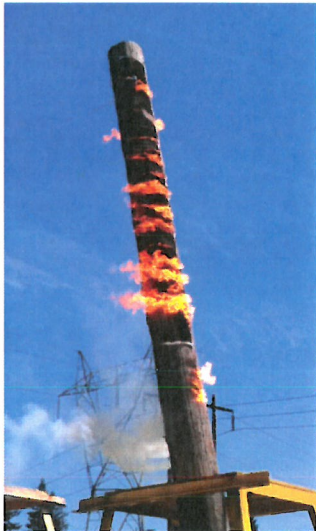
Figure 1 – Untreated Wood Pole Burning

Both poles burned while the voltage was applied. The treated pole burned less vigorously and extinguished itself more quickly than the untreated pole.

Both poles burned while the voltage was applied. The treated pole burned less vigorously and extinguished more quickly than the untreated pole.

While the treatment will not prevent electrically-caused pole fires, it may limit the damage to the structure in some cases.

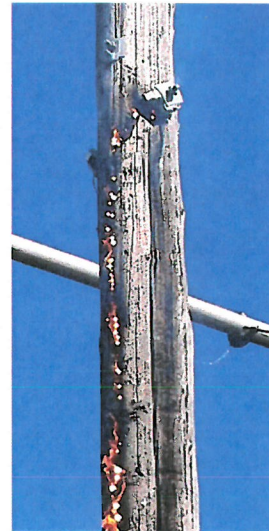
Figure 2 – Treated Wood Pole Burning

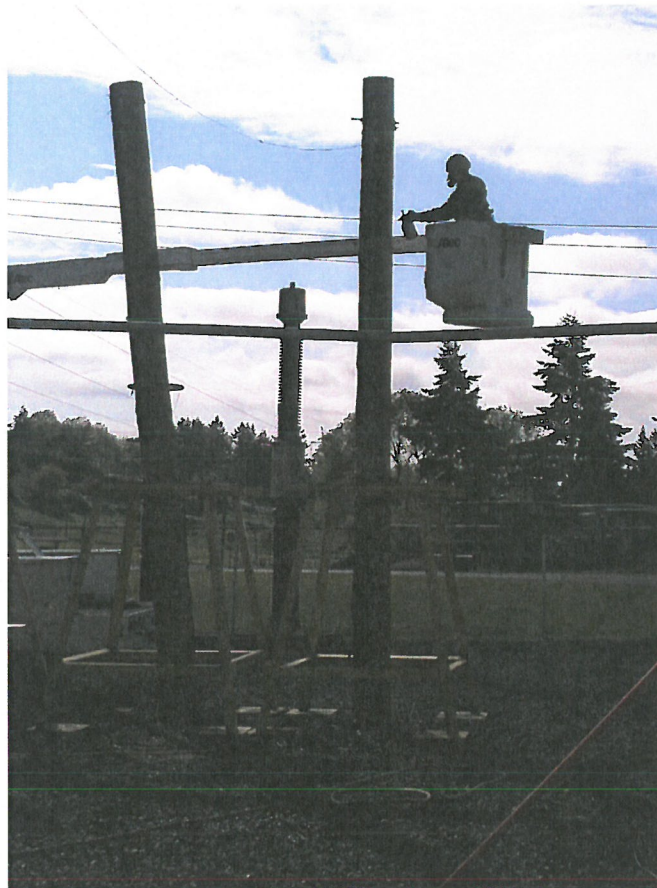
One of the cedar poles was treated with the SPF3000 fire retardant treatment manufactured by Sun Fire Defense, Marina Del Ray, California. The treatment was applied by a BPA painter who used a chemical sprayer to apply the treatment. The other cedar pole was left untreated.

Figure 3 – Applying the Fire Retardant Treatment Using a Chemical Sprayer.

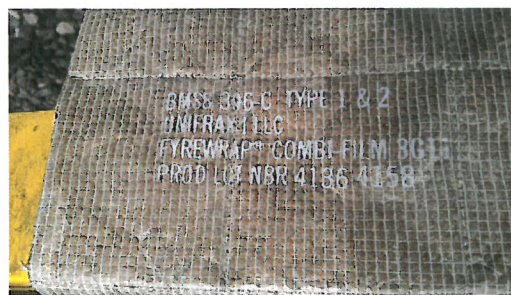
A fire blanket was installed around the through-bolt of the treated pole. It was difficult to assess the effect (if any) the blanket had on the test results.

Figure 4 – Fire Blanket Material Used to Wrap the Through-Bolt on the Treated Pole.

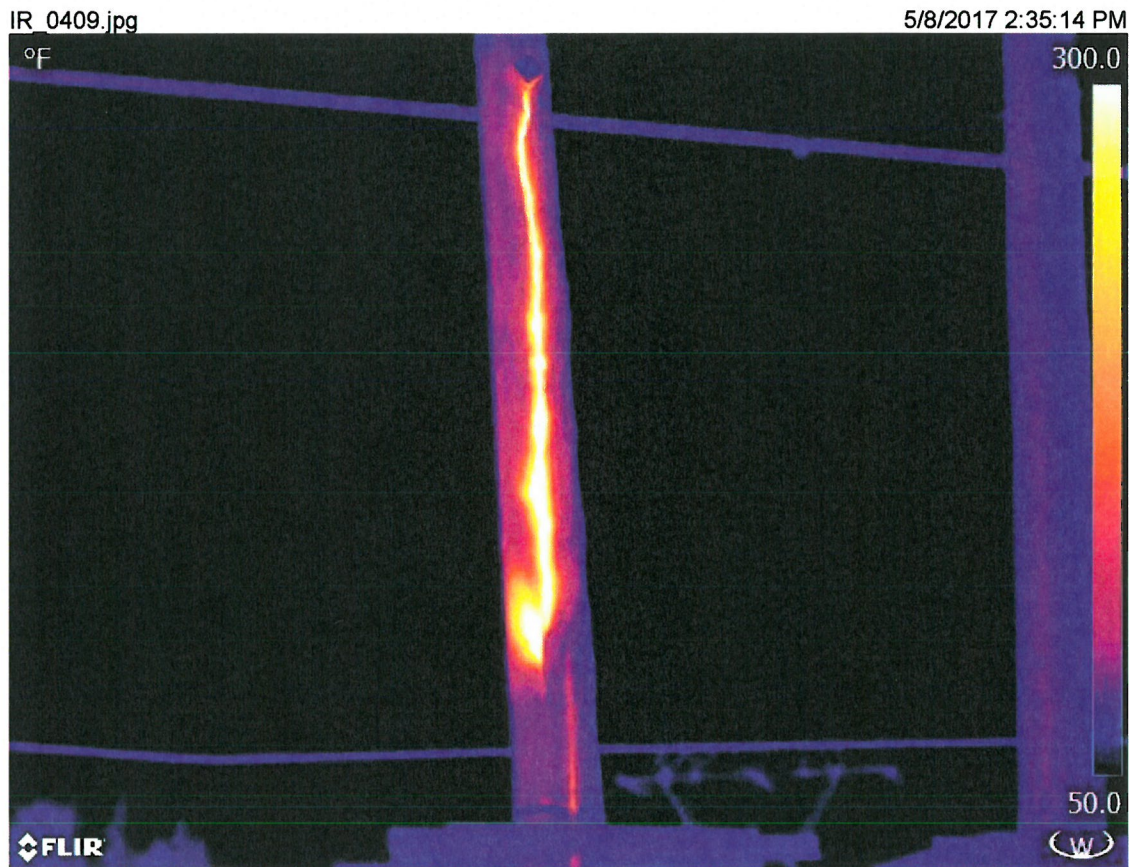
Infrared images were taken of the initial tests on the treated pole. The infrared image clearly shows the path of the current through the pole. Temperatures indicated in the image are approximate since the emissivity of the pole is not known.

Figure 8 – Infrared Image of the Burning Pole
