ENGINEERING AND TECHNICAL SERVICES REPORT

EVALUATION OF WOOD POLE FIRE RETARDANT TREATMENT			DATE May 25, 2017	REPORT NO. TEST-17-050-Revised
			AUTHOR J.G. Hildreth – TEST-MODA <i>JGH</i>	
			Assisted By R.S. Dizon – TEST-MODA	
REQ ORG. TELM	PAGES 5	ABMW.O. 17-035	REVIEWED BY S. Khem – TEST-MODA <i>S. Khem</i>

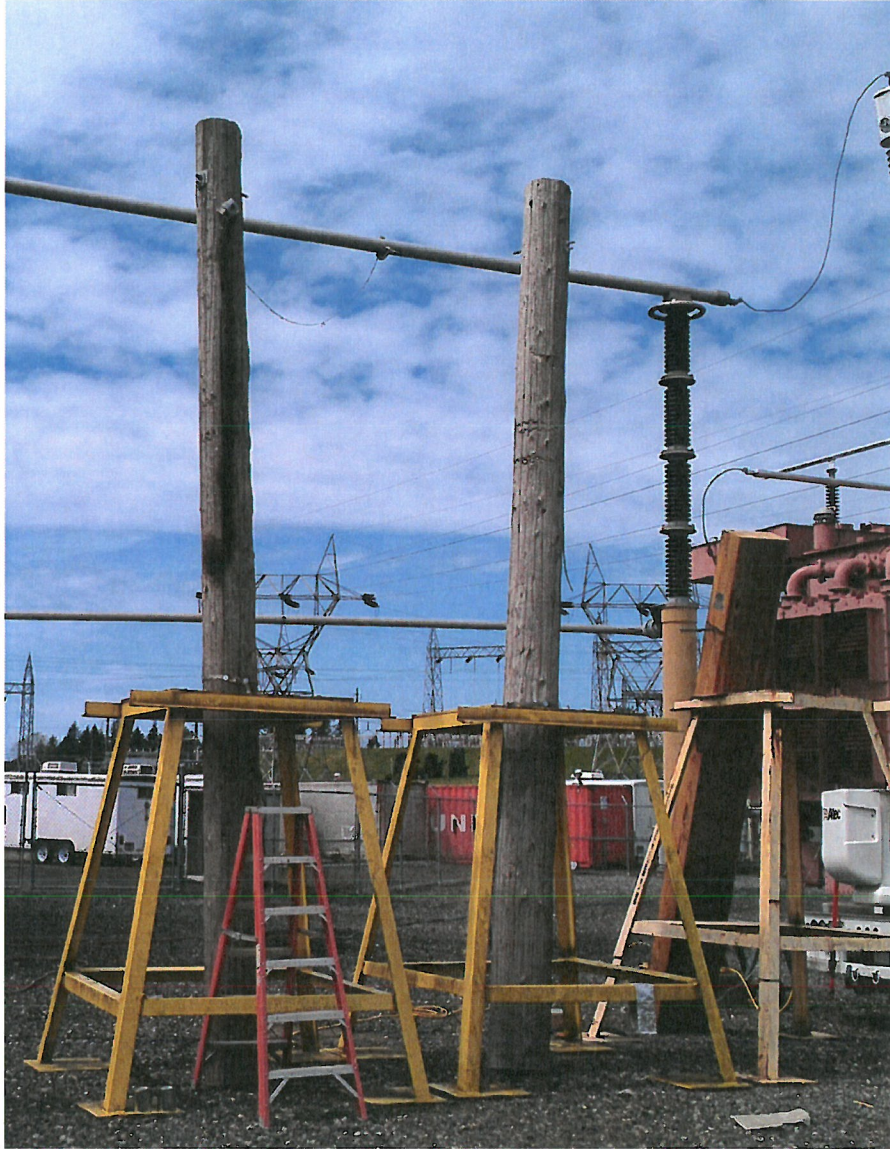
Figure 5 – Test Samples Erected Into Bushing Stands at the Fog Chamber.

The pole sections were erected into bushing stands in the Fog Chamber yard. A through-bolt was installed in the top of the pole. A conductive band was formed around the bottom of the pole just above the stand. The conductive band consisted of 1" wide tinned copper braid fixed to the pole with screws.

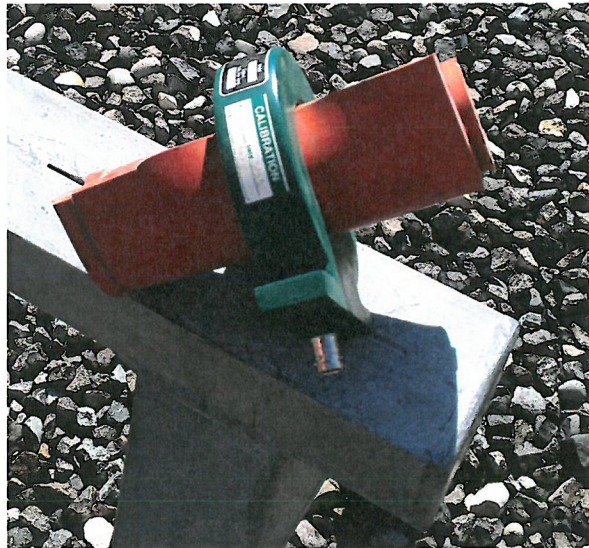
Figure 6 – Current Transformer.

The through-bolt was energized from the 460-kV winding of the Fog Chamber test transformer. The conductive band was grounded through a Pearson 110a current transformer used to measure the current through the pole.

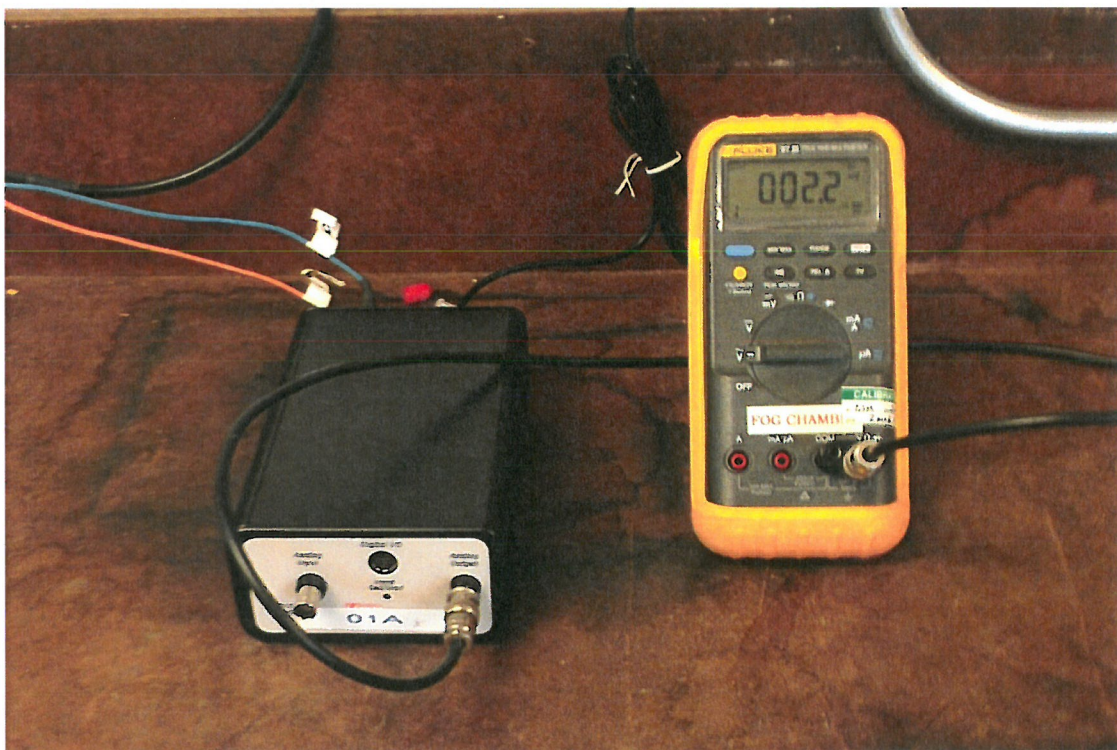
Figure 7 – Current Displayed on a Handheld Fluke Meter.

A TeraHertz fiber link was used to transmit the current measurement into the control room where it was displayed on a handheld Fluke meter.
